Was it operator error or human error?

Commodore David Squire, CBE, FNI, FCMI Editor, **Alert!** The international Maritime Human Element Bulletin

Operator Error or Human Error?

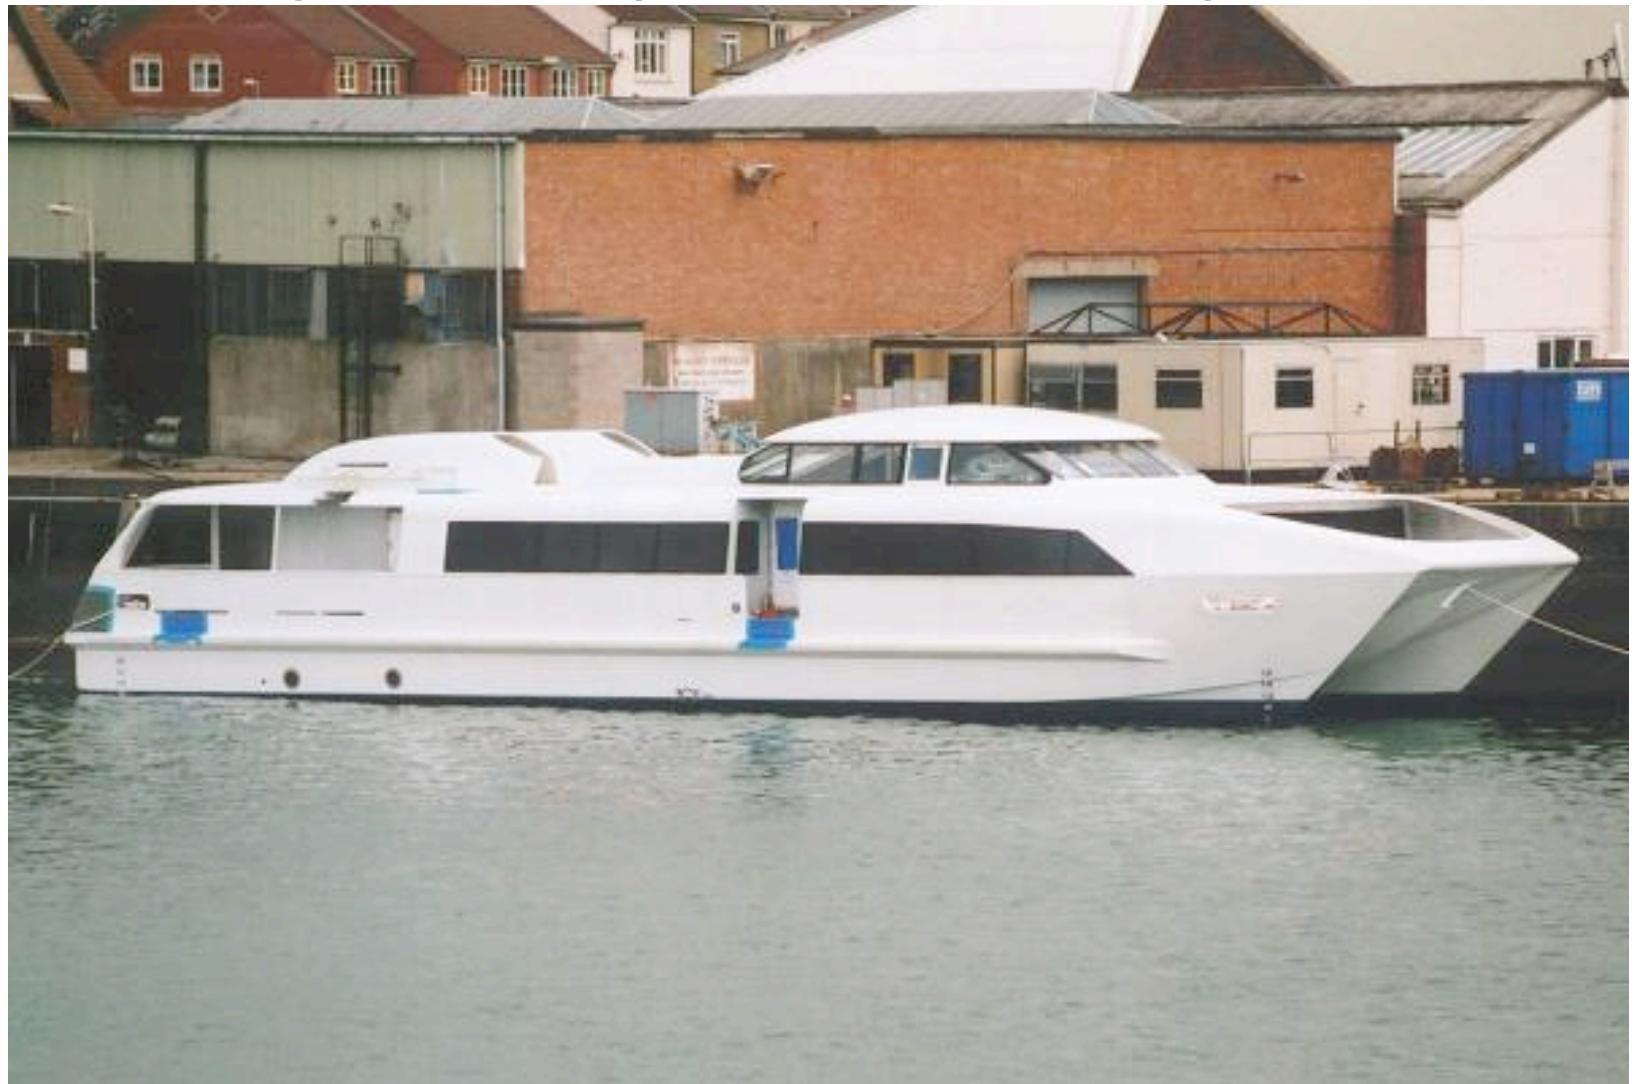
Grounding of the High speed passenger craft Katia

First of three identical vessels to be operated by a longterm charterer, who provided the shipbuilder with the detailed design specification for the vessels, based on their expected operating requirements

During the design and build stages, the shipbuilder's trials master was given copies of the vessel's operations manual and details of the layout of the operating compartment

Despite the trials master bringing some deficiencies to the attention of the builders, the charterers subsequently directed that no changes should be made to the layout

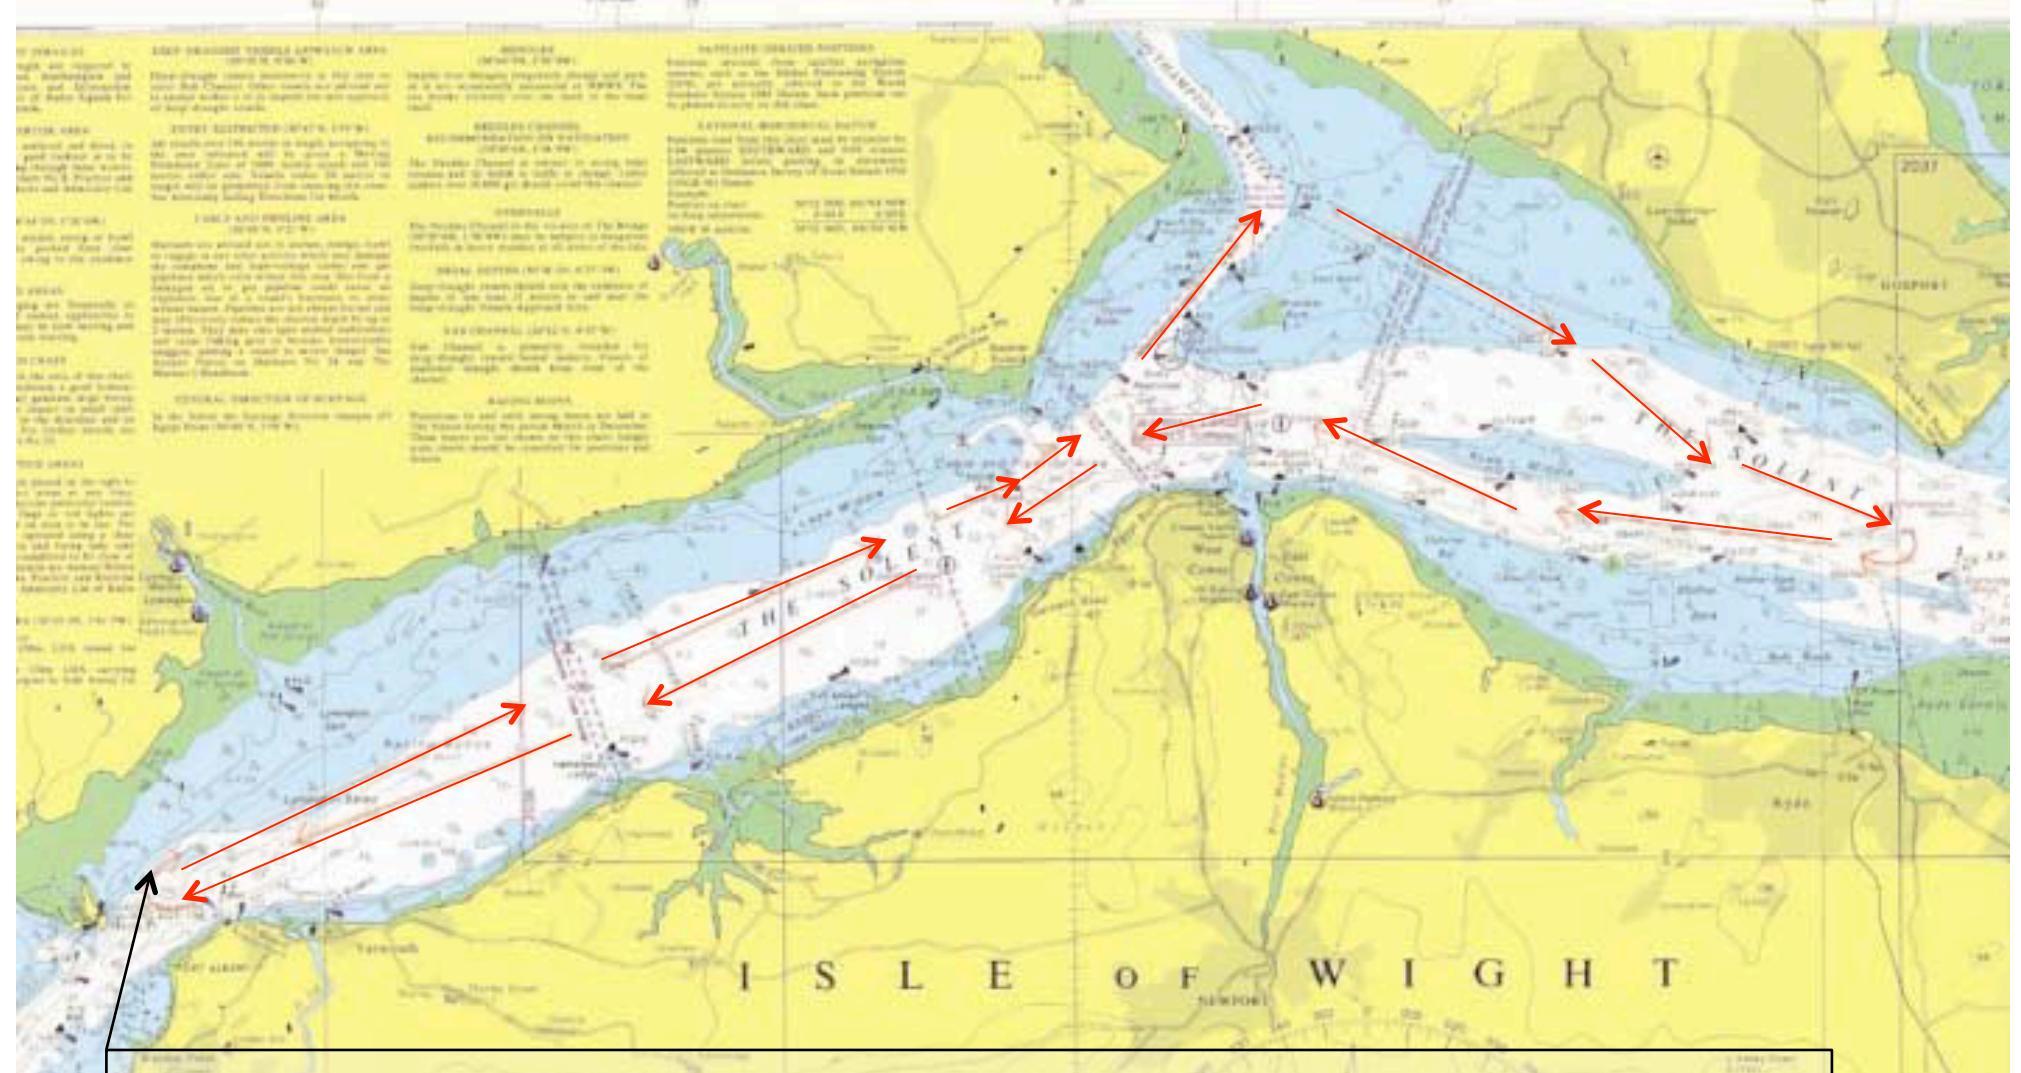
The vessel grounded during maximum speed endurance trials, while making a speed of 38 knots and approaching a turn on the most westerly section of a planned 32-mile circuit of the Solent The vessel was being conned by the chief officer and was approaching the western limit of the circuit. The chief officer kept the *Katia* on track by slewing the vessel between the red and white sectors of Hurst Point light

The chief officer was distracted by a conversation with the charterer's representative, who had been allowed to visit the bridge while the vessel was underway at night

This caused him to miss the correct position for the start of the turn and ultimately led to the vessel grounding The trials master was an experienced high speed craft type rating examiner who, on paper, showed the qualities necessary for an adequate trials master of a prototype vessel

An important contributing factor to the accident was that the chief officer had little visual indication of his advance towards Hurst Spit once he had passed Sconce buoy

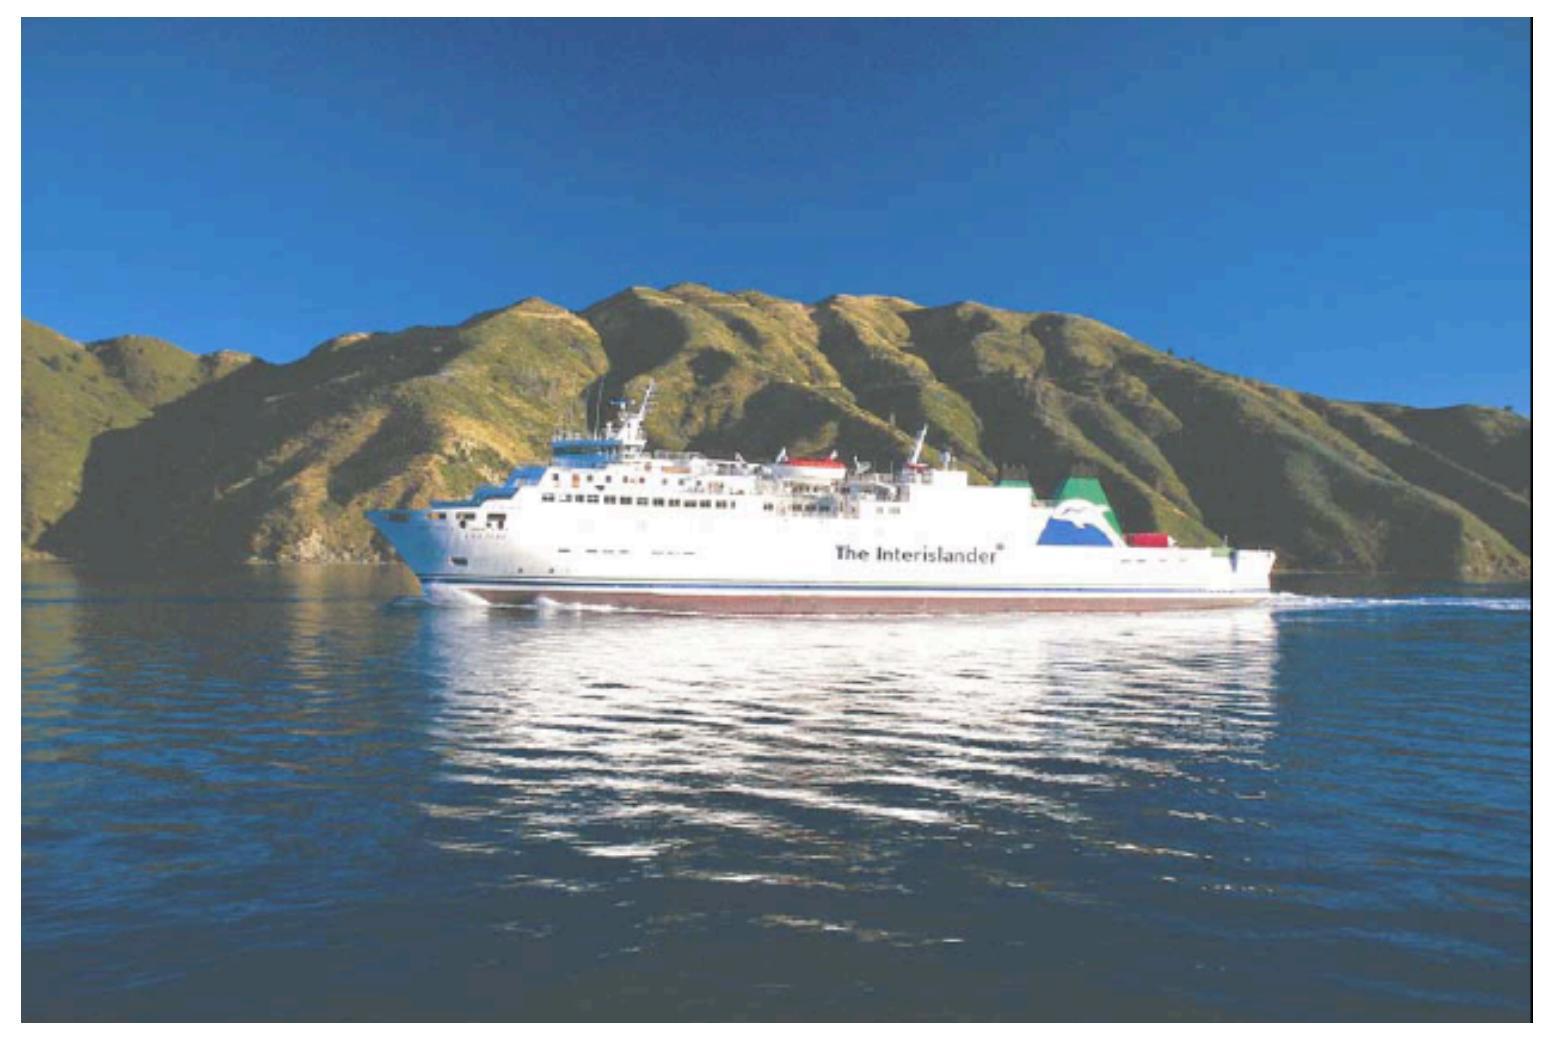
FIGURE 1 ARATERE - NEAR GROUNDING

Failed to make a programmed course alteration while in automatic steering, during the approach to a narrow channel

The ship did not make a planned automatic turn to port, and
 recovery from the situation required swift intervention by the
 master to initiate the turn manually and prevent the ship
 grounding

The ARPA radar navigation system probably defaulted from the ANTS mode to autopilot mode without the change being noticed by the mate or master

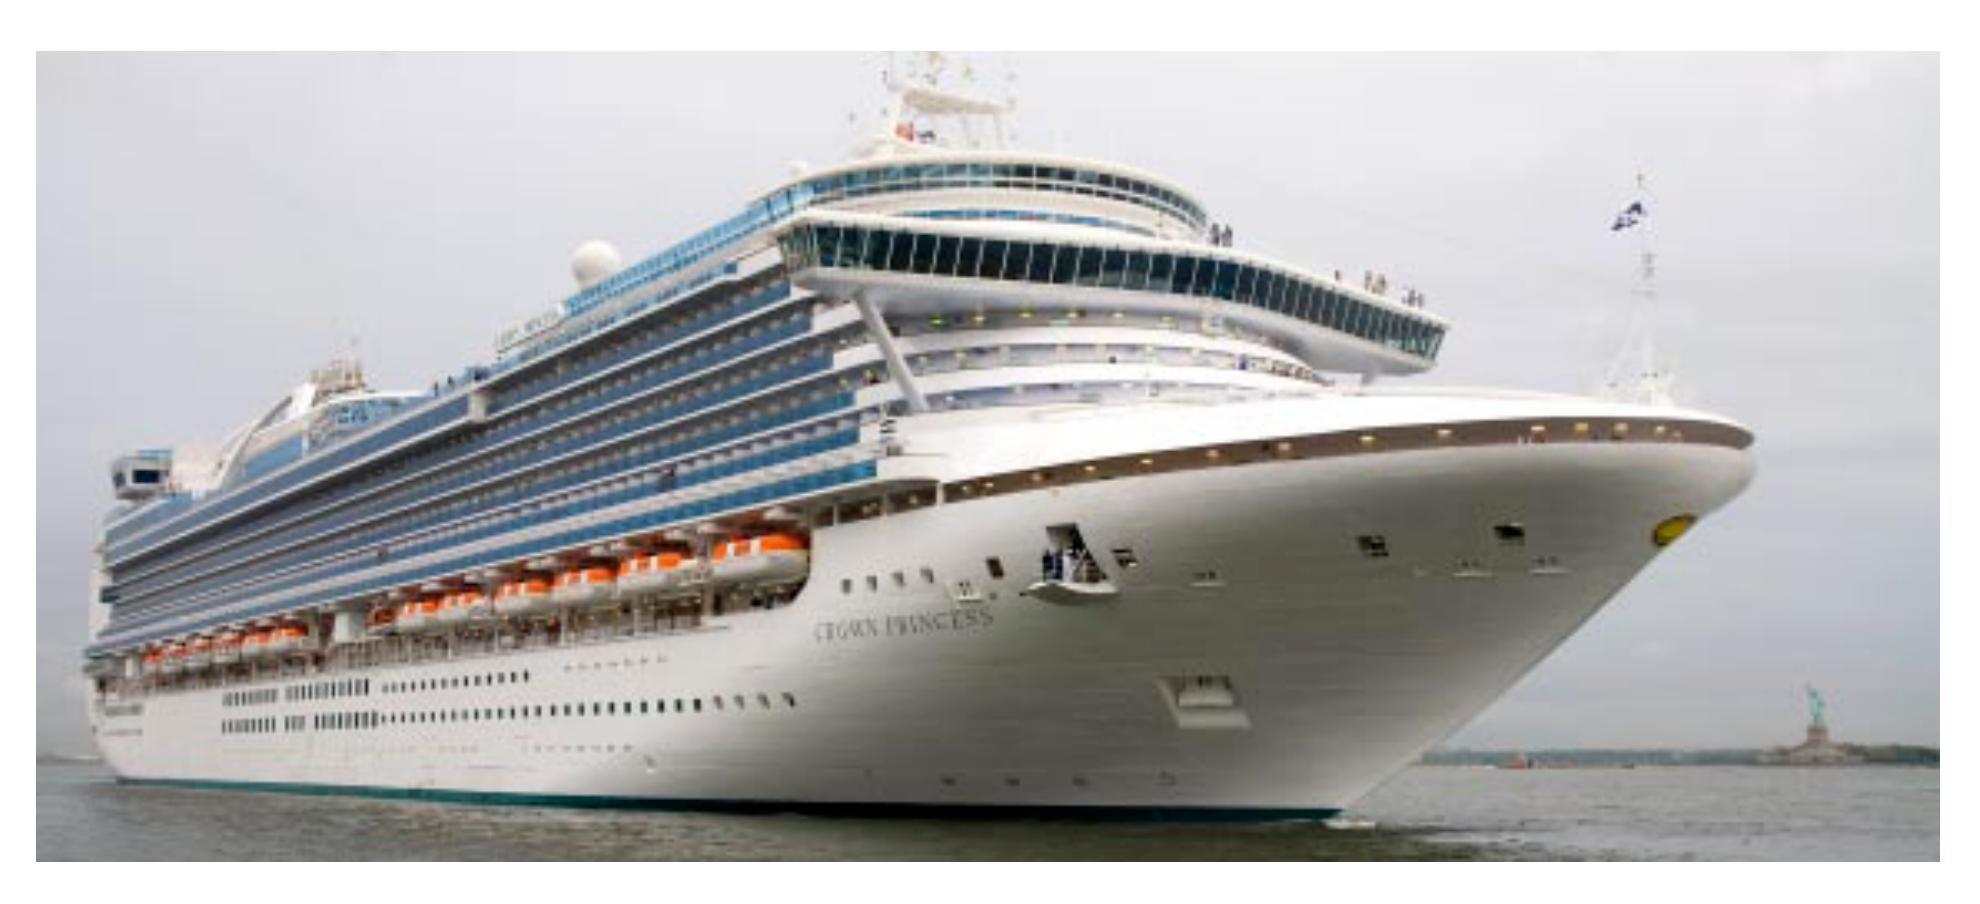
Heeling accident aboard the cruise ship Crown Princess

In an effort to counter the effects of a perceived high rate of turn, the second officer disengaged the automatic steering mode of the vessel's integrated navigation system and took manual control of the steering

He turned the wheel first to port and then from port to starboard several times

These actions eventually caused the ship to heel at a maximum angle of about 24° to starboard

The heeling caused people to be thrown about or struck by unsecured objects, resulting in 14 serious and 284 minor injuries to passengers and crew members The vessel incurred no damage to its structure but sustained considerable damage to unsecured interior components and to cabinets and their contents
