Analysis of the Effects of Atmospheric Noise on Loran-C

Presented by Curtis Cutright to the International LORAN Association 34th Annual Convention and Technical Symposium Santa Barbara, CA October 19, 2005

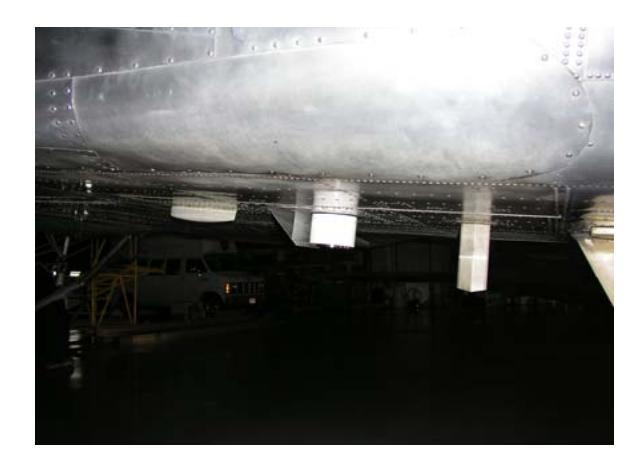
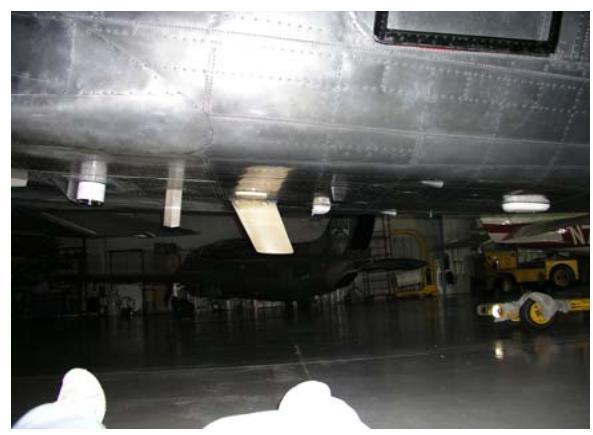
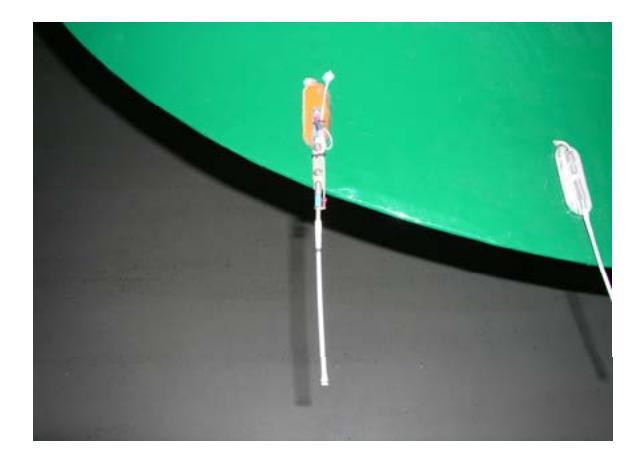
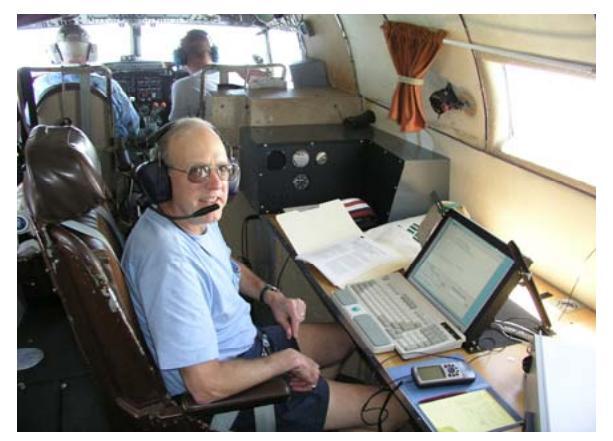
- DC-3 Instrumentation
 - ≻ Field Mill
 - Instrumented static dischargers
 - Reelektonika DataGrabbers
- Instrumentation calibration
 - > One week after TMB flight testing
 - \succ No changes to aircraft
- Flight Testing
 - ≻ TMB July 2005
 - Thunderstorm and p-static noise

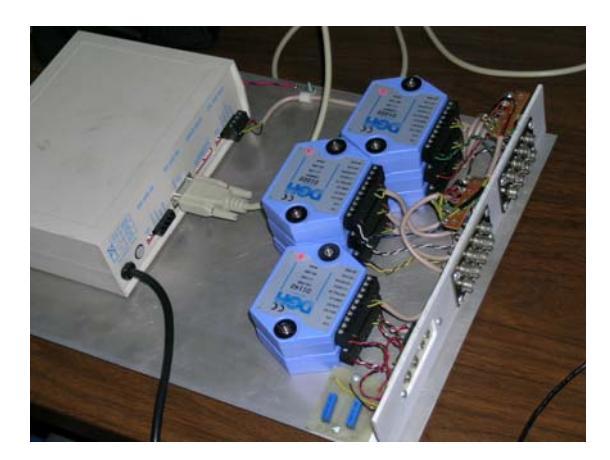
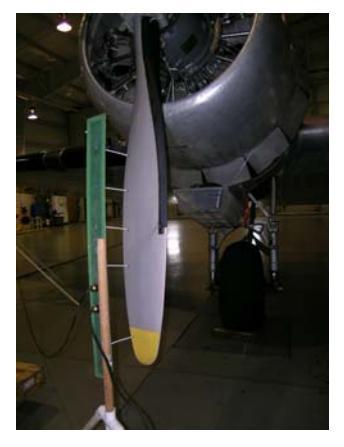
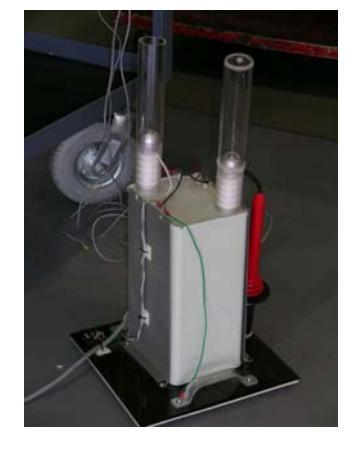
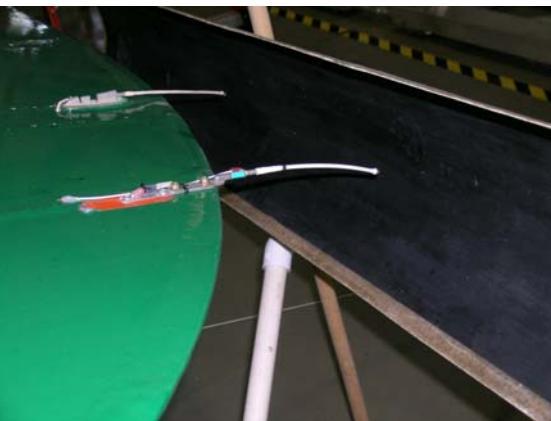
Equipment Setup

- Performed the week of July 25th, 2005
- Equipment
 - ≻ HVPS
 - Static charge flood and collection fixtures
 - ≻ Field mill calibration plate
 - Ground data collection system
 - ♦ DGH digital meters
 - ➢ Aircraft data collection
 - ◆ DGH digital meters
 - ♦ Field Mill

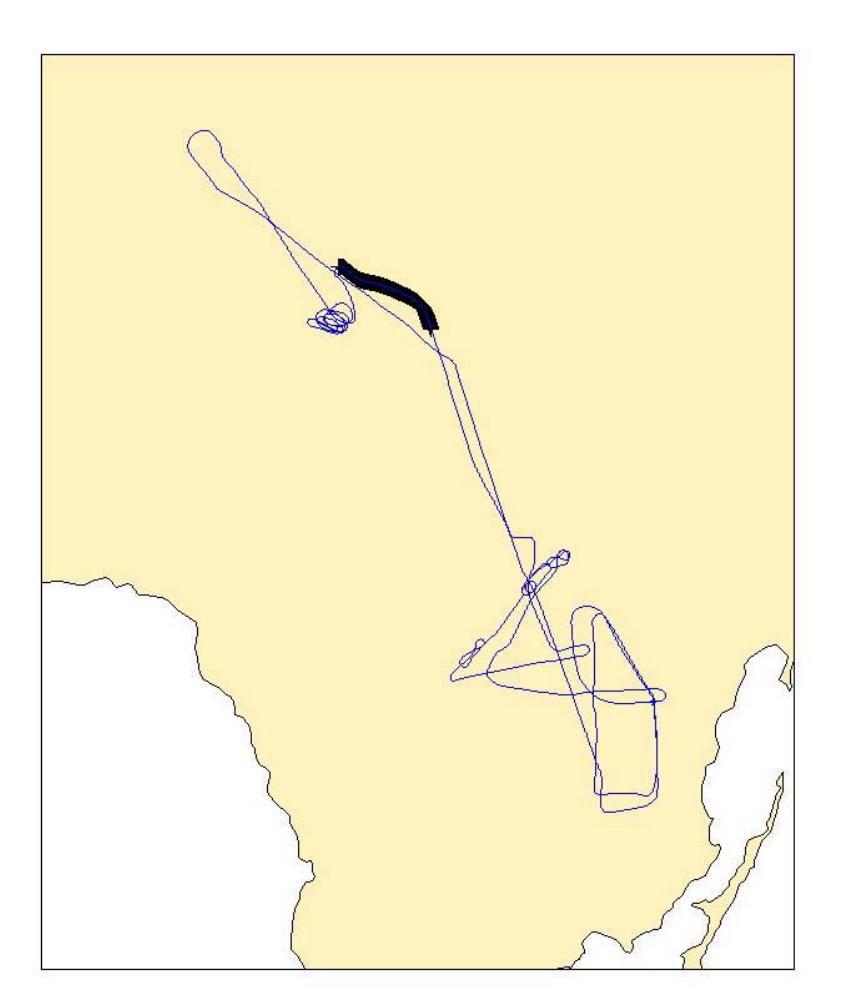
Flight Test Results (2 of 17)

- July 12, 2005 flight test
 - ≻3.5 hour flight
 - Encountered several areas of significant p-static activity
 - ≻No significant lightning activity

- Significant p-static conditions were encountered during the July 12 flight
 - Results showed that the h-field is not significantly affected by aircraft charging
- Moderate-to-severe lightning was in the area for the July 13 flight
 - Effects are generally similar for both e-field and h-field
 - No significant impact on the ability to identify LORAN signals

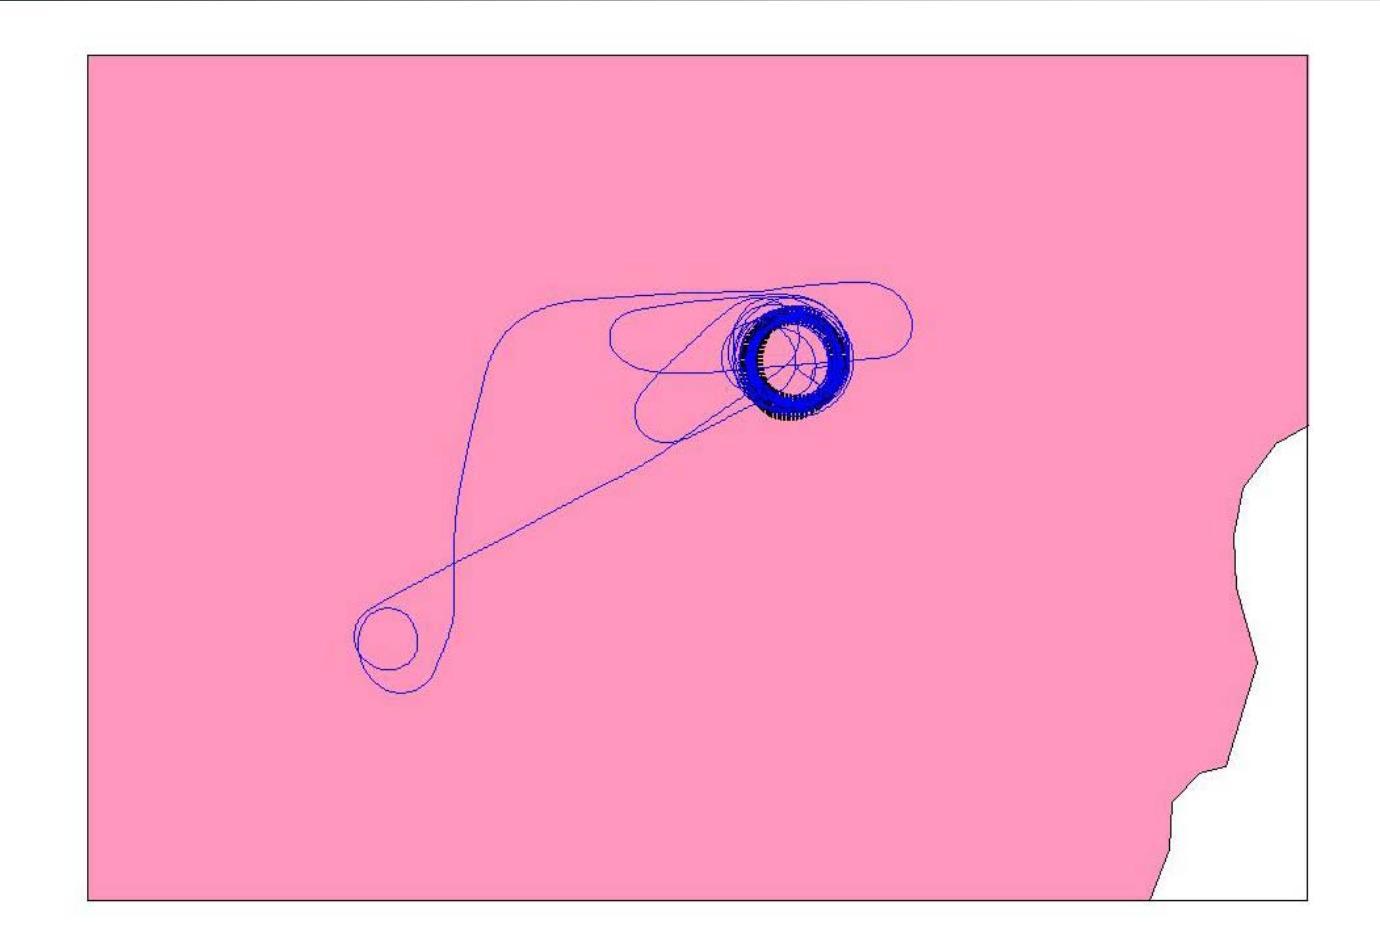
Flight Test Results (11 of 17)

- July 13, 2005 flight test
 - ≻1.5 hour flight
 - Avoided areas of p-static to only get lightning effects
 - Circled over the ground station for approximately 1 hour
 - Stanford recording data at the same time
